Waterco Case Study | Sea lion enclosure – Blackpool Zoo

California Dreaming

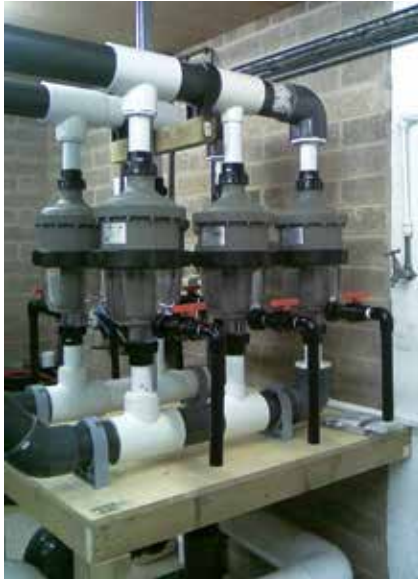
▲ Water is fed through six MultiCyclone pre-filters and then through six Micron Deep Bed media filters filled with glass.

For the sea lion enclosure, Waterco suggested a chlorinated filtration system using two cast iron pumps connected to existing pipe work. The water was then fed through six MultiCyclone centrifugal pre-filters and then through six Micron Deep Bed media filters filled with glass media before the water was chlorinated and then returned to the pool.

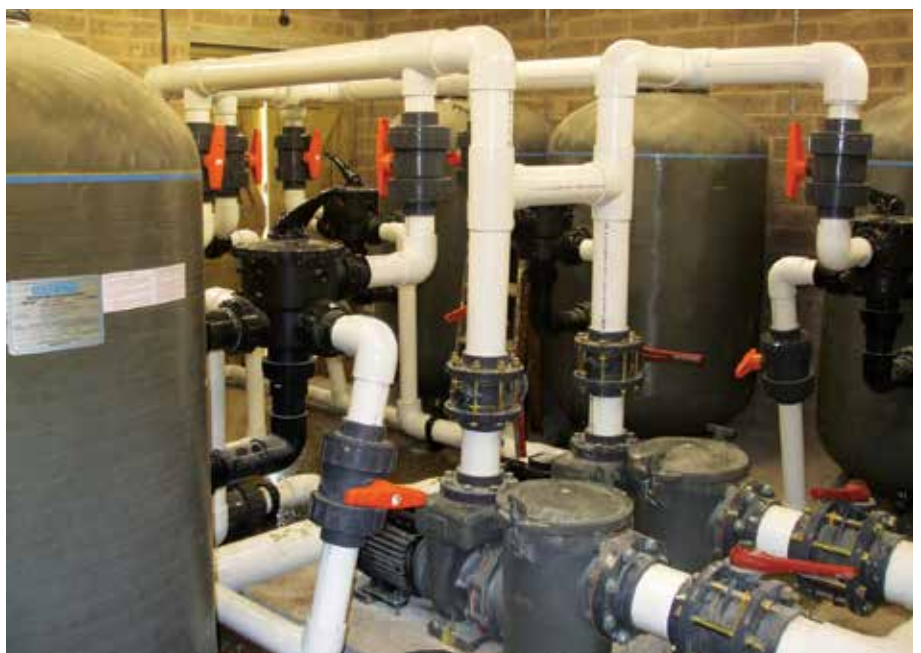
► For the sea lion enclosure, Waterco suggested a chlorinated filtration system using two cast iron pumps connected to existing pipe work.

Also installed were a hidden Hydrostar pump, which is made for large commercial swimming pools, with a three inch pipe feed to the waterfall, and two poolside pumps disguised in artificial rocks to draw water from the pool and re-circulate to the bottom.
